LuxaCrown Case Reports

A series of case reports showing clinical challenges and their treatment solution with LuxaCrown, a new semi-permanent restoration material.

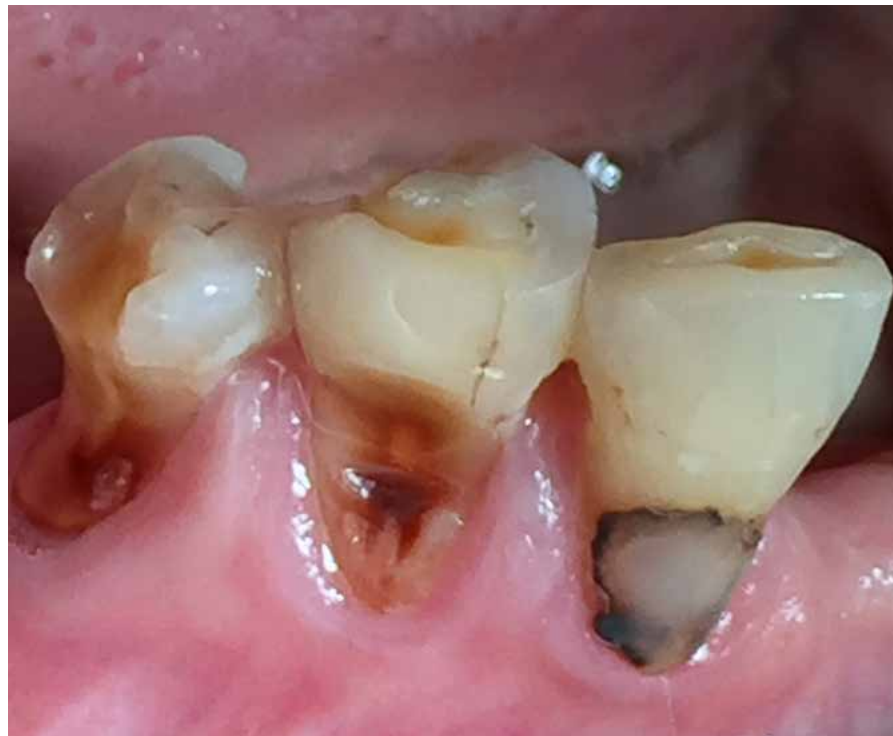
Fig. 2: Compromised teeth.

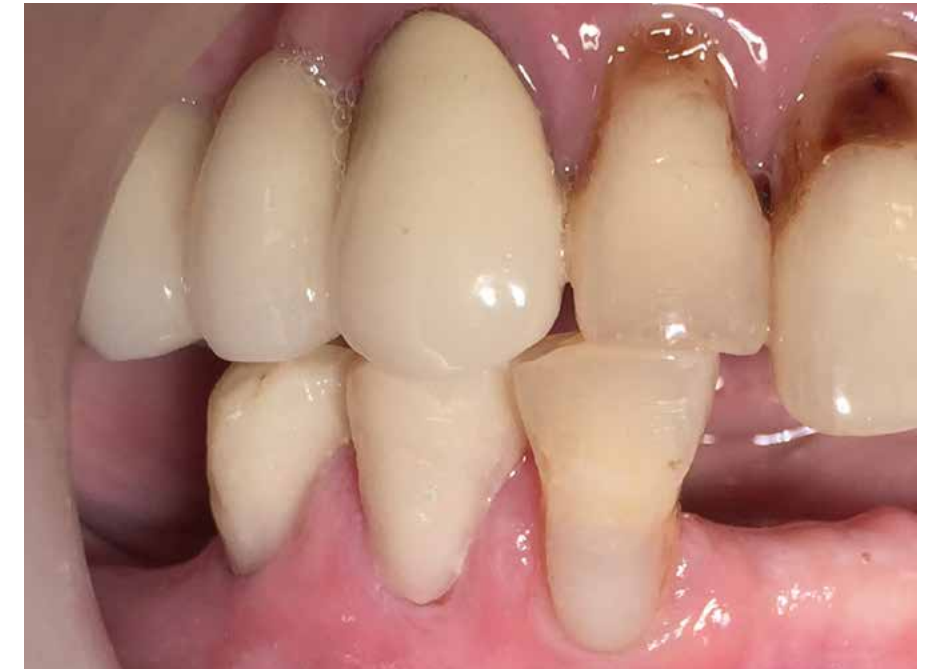
Fig. 8: Intraoral situation without removable partial denture in situ 2 weeks after treatment. The vestibular filling at the lower canine next to the restored teeth had also been replaced.

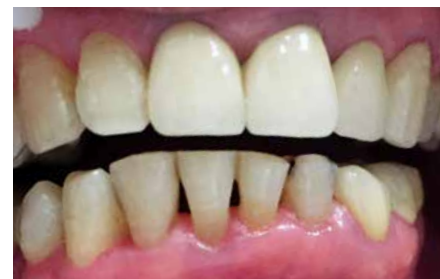
Fig. 1: Intraoral initial situation.

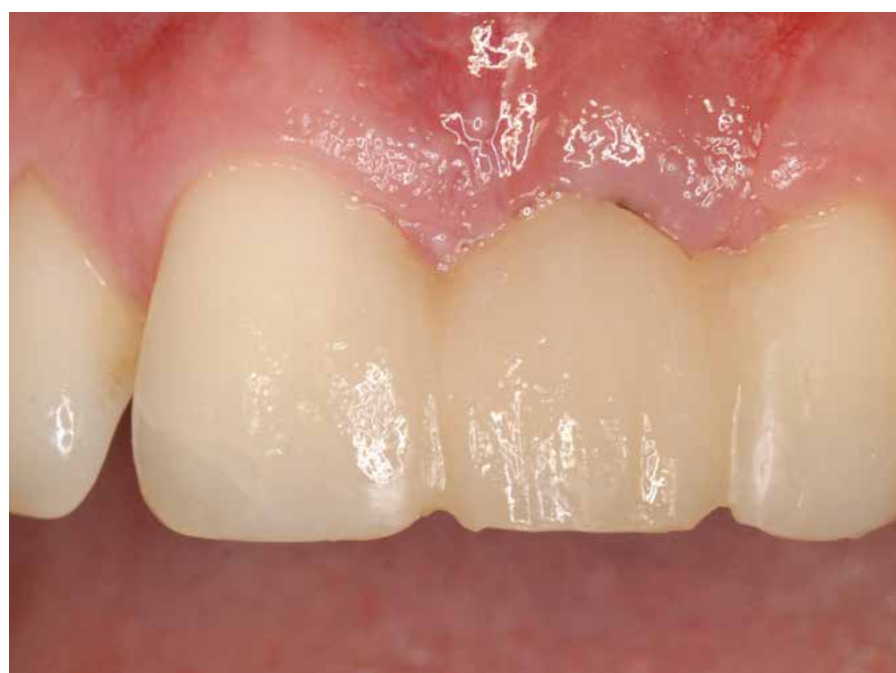
Fig. 1: Composite bridge over implant 21.

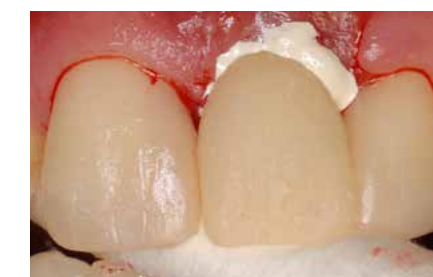
Fig. 7: Insertion of the restoration with TempBond while patient bites down lightly on cotton wool roll.

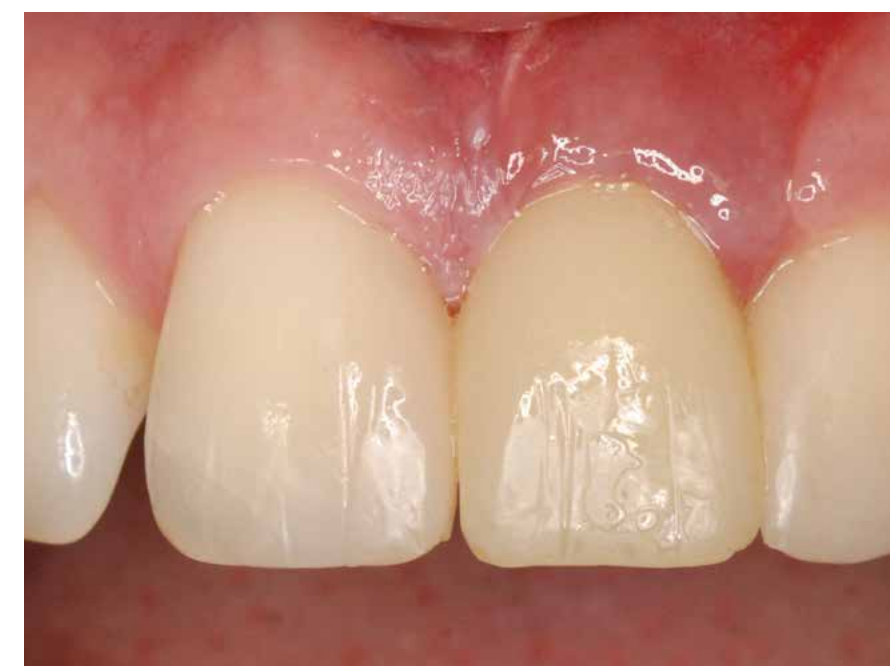
Fig. 8: Restoration after a few days in mouth.

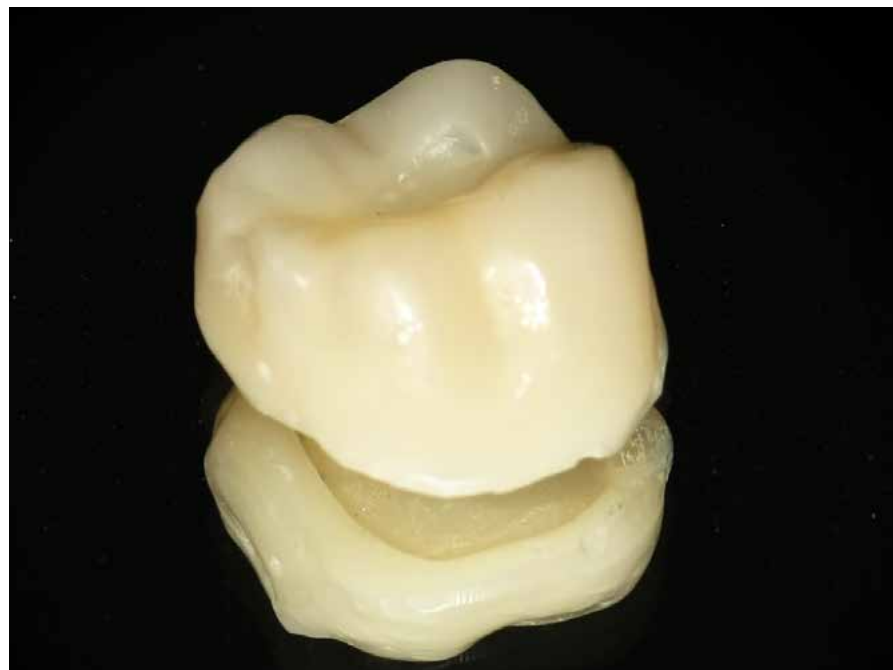
Final LuxaCrown restoration on a mirror.

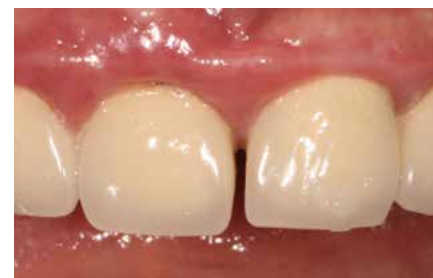
Fig. 1: Initial situation frontally.

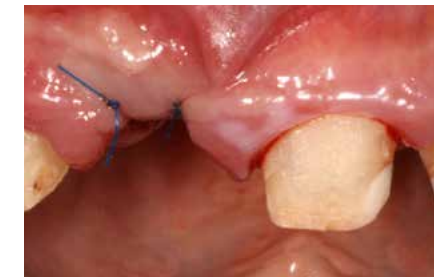
Fig. 8: Provision of caries lesions with fillings.

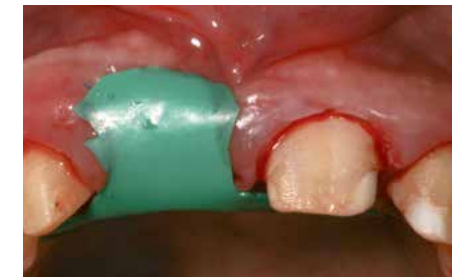
Fig. 9: Coverage of extraction wound with rubber dam.

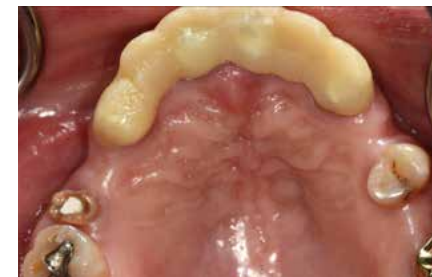
Fig. 1: Initial situation maxilla from occlusal.

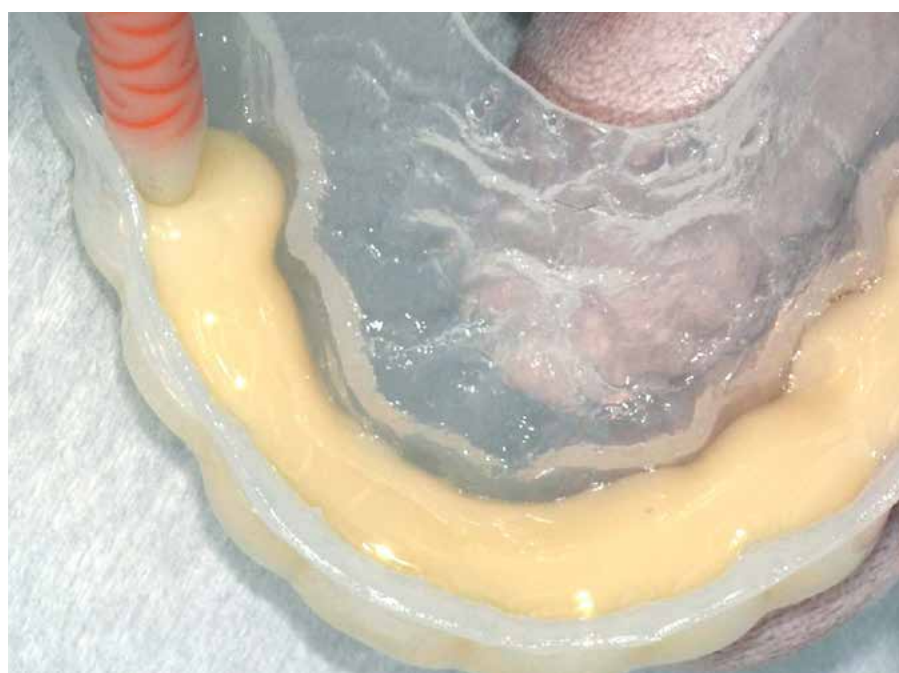
Fig. 10: Vacuum-formed stent filled with LuxaCrown without any air bubbles.

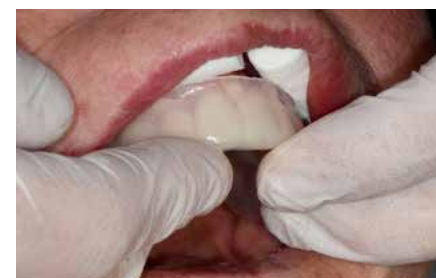
Fig. 11: Intraoral fabrication of the restoration.

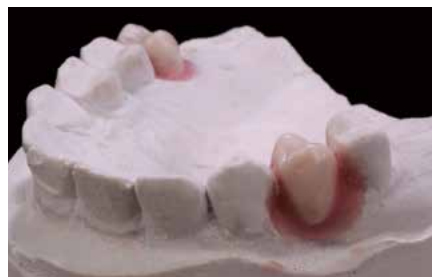
Fig. 1: Situation model with prosthetic teeth in position.

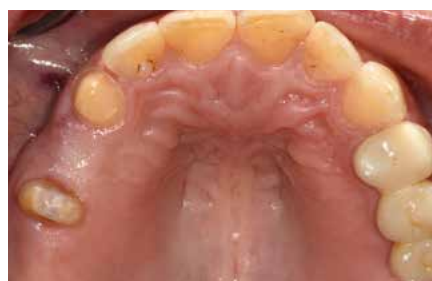
Fig. 3: Prepared cores 13 and 15 from occlusal.

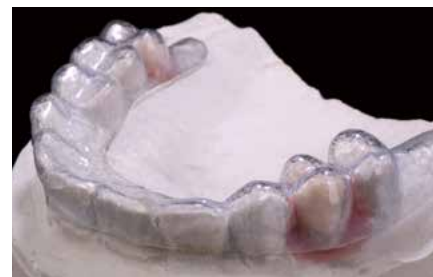
Fig. 2: Situation model with prosthetic teeth in position with vacuum-formed stent.

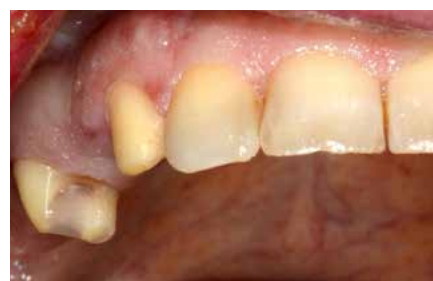
Fig. 4: Prepared cores 13 and 15 from frontal.

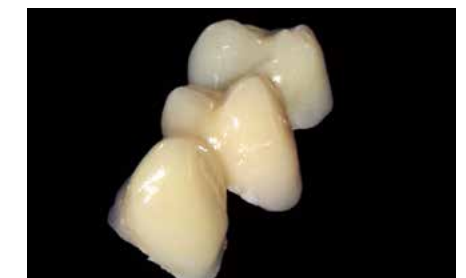
Fig. 11: Completion of the semi-permanent LuxaCrown restoration with Luxatemp-Glaze & Bond.

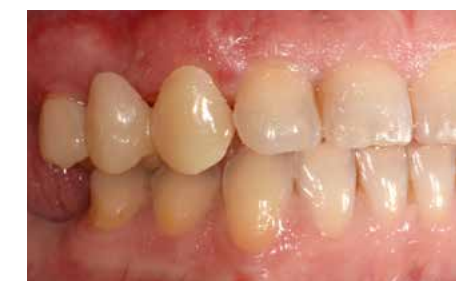
Fig. 13: Inserted semi-permanent LuxaCrown restoration from buccal.

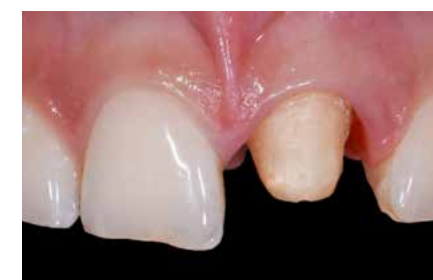
Fig. 4: Condition following removal of the old crown.

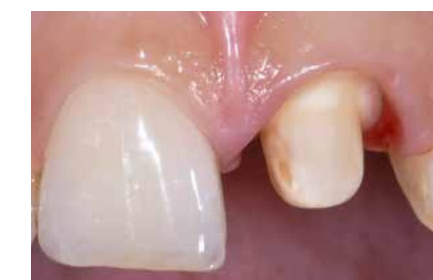
Fig. 5: Condition following post-processing.

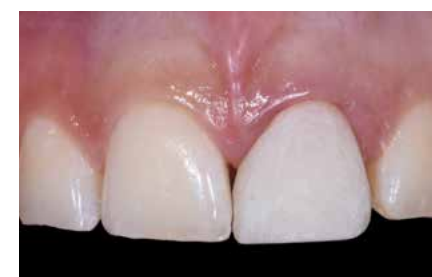
Fig. 6: Temporary crown following rough preparation.

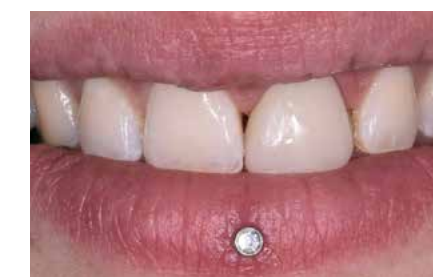
Fig. 8: Semi-permanent crown 21 straight after insertion, frontal view (when smiling).

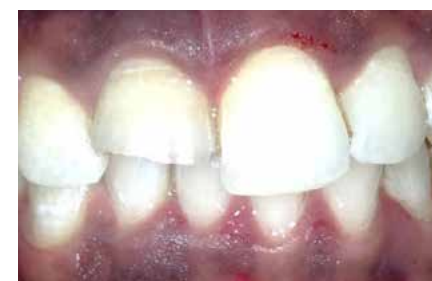
Fig. 1: Pre-operative situation.

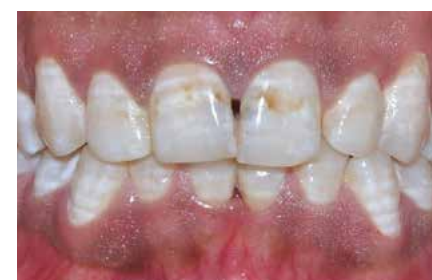
Fig. 1: Pre-operative situation.

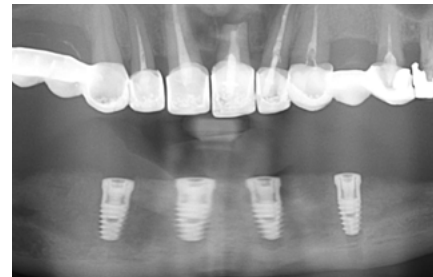
Fig 1: Initial panoramic radiograph.

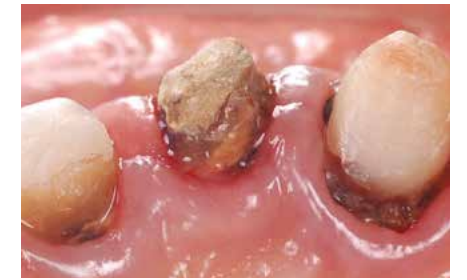
Fig. 5: Multiple extensive carious lesions..

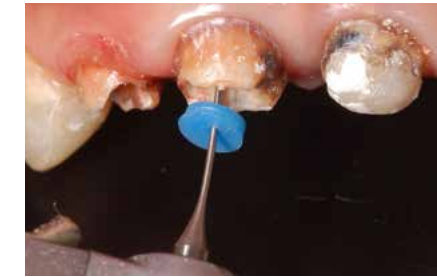
Fig. 6: Endodontic reentry.

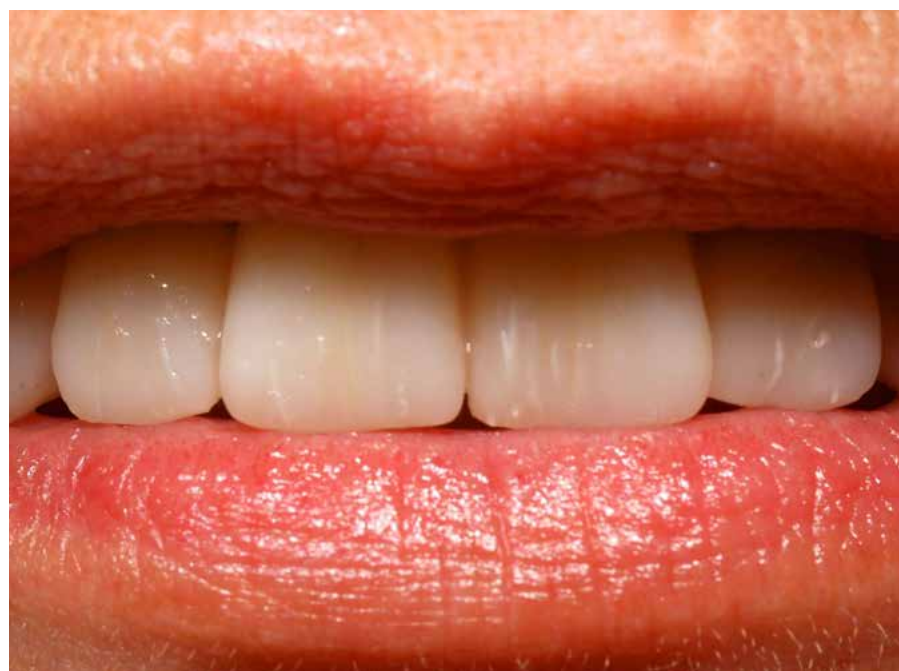
Fig. 13: Pleasing final outcome – oral harmony reestablished.
